Sentinel R8.1 Release Notes

Release Date: November 2017

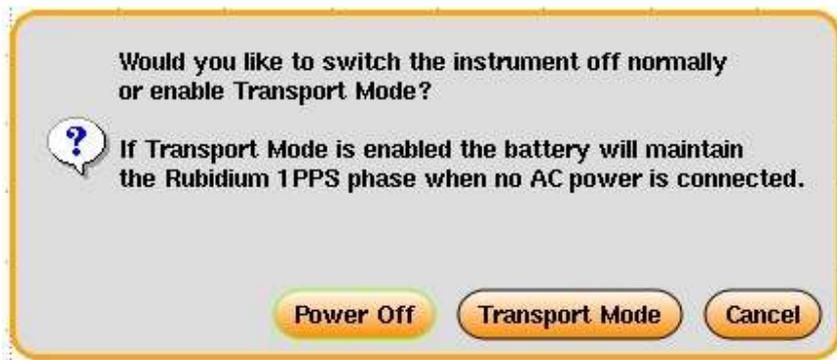
If the battery is present the following pop-up is displayed:

These pop-ups have been replaced by a single pop-up with all options displayed.

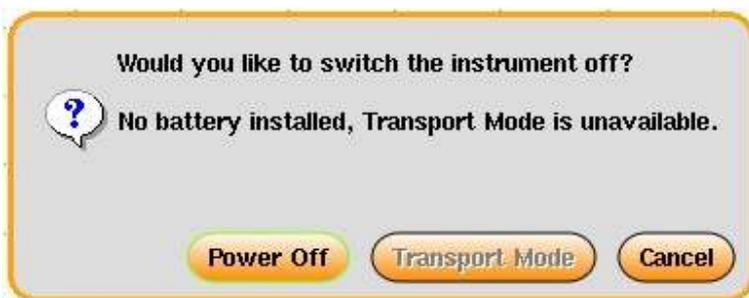
If the battery is not present the following pop-up is displayed:
